## OFFICE OF THE SPECIAL INSPECTOR GENERAL FOR AFGHANISTAN RECONSTRUCTION

# INSPECTION OF MAHMOOD RAQI TO NIJRAB ROAD PROJECT IN KAPISA PROVINCE:

CONTRACT REQUIREMENTS MET;
BUT SUSTAINABILITY CONCERNS EXIST

SUBJECT: SIGAR Inspection Report 09-02: Mahmood Raqi to Nijrab Road Construction Project in Kapisa Province: Contract Requirements Met, But Sustainability Concerns Exist

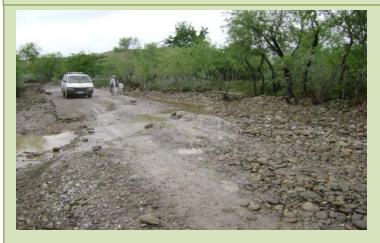
The road from Mahmood Raqi to Nijrab before construction, April 2009 (Photo provided by SIGAR)

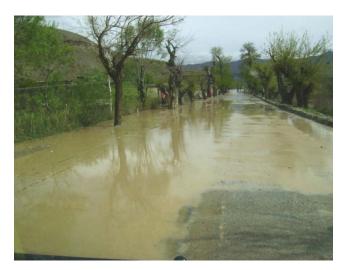
Site Photo 1: Example of a flooded portion of the road prior to construction. The road was subsequently leveled and re-paved. (Photo provided by Kapisa PRT)

road flooded and turned to mud (see photos 1 and 2). In the higher elevations and colder sections of the province, the roads experienced ice and snow accumulations that left steep uphill sections largely impassable and dangerous for traffic. In the hot, dry months of summer and early autumn, traffic on the roadway was subjected to swirling clouds of dust that at times limited visibility to less than 3 feet. These hazards were accentuated by several sections of the road with hairpin turns to accommodate the steep grades and sections where the road narrowed to less than one lane wide.

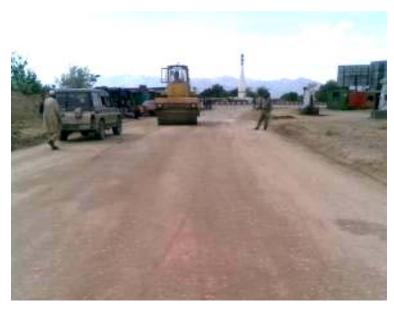
Site Photo 3: A view of the Mahmood Traffic circle facing west along the road to Nijrab in April 2009 shortly after the project's earth work phase commenced. The photo shows the road's sub-grade layer being compacted with a vibratory drum roller. (Photo provided by Kapisa PRT)

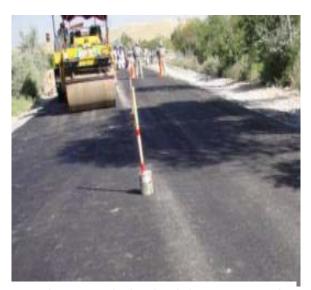
Site Photo 5: Newly placed asphalt wear course with vibratory drum rollers performing compaction. (Photo taken by SIGAR)

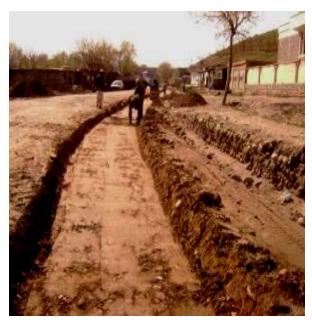
Site Photo 6: A view of the exposed and compacted subgrade soil layer as the road was being cut and widened in Arokhi village section of the road. (Photo provided by Kapisa PRT)

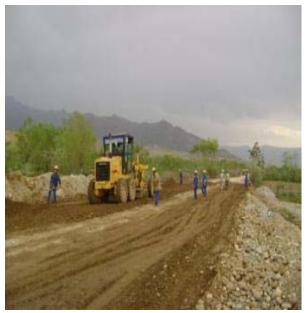
Site Photo 7: A view of the road being graded after the ground was filled in order to make the shoulders wider and level. (Photo provided by Kapisa PRT)

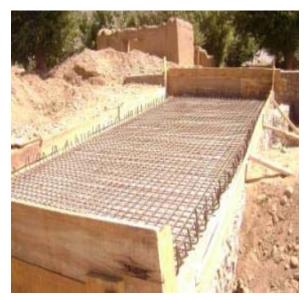
Site Photo 8: A rebar and wood formwork prepared to construct one of the 26 slab culverts required by the design plan. (Photo provided by Kapisa PRT)

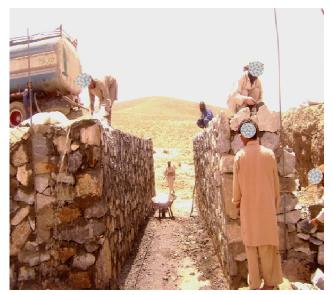
Site Photo 9: The wing walls of a stone masonry foundation for one of the 29 box culverts required by the project design plan. Of note are workers properly curing the cement mortar in the upper left hand corner of the photograph in order to allow it to develop its bonding strength. (Photo provided by Kapisa PRT)
